Notice of Study Commencement United Counties of Stormont, Dundas and Glengarry County Road 22 Reconstruction and Drainage Improvements

A survey was conducted on May 17, 2022, to document existing cross culverts which may require replacement within the limits of the County Road 22 (CR 22) Project Area. Additionally, cross culverts and subsamples of driveway culverts and drainage ditches (mostly components of municipal drains) were cursorily assessed to determine if any have the potential to provide fish habitat. An additional survey was completed on September 28, 2022, to both identify additional culverts in the expanded Project Area (eastward) and to complete fish community surveys at select locations where potential fish habitat was identified. This was a non-exhaustive assessment of fisheries potential in the Project Area from which a submission package to environmental regulatory agencies could be developed.

ATTACHMENT 2 – Photographic Diary

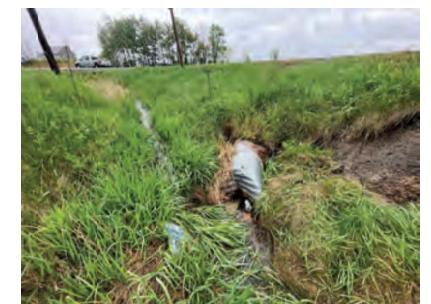
Culvert #1: Damaged, 600 mm CSP immediately east of Highway 138. Proposed to be replaced.

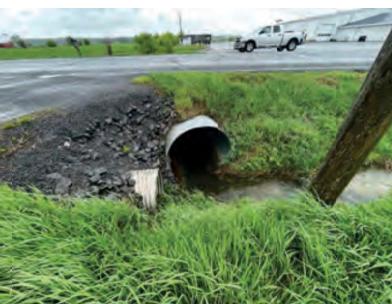
Culvert #2: Corroded, 1500 mm CSP west of 17515 CR 22. Proposed to be replaced.

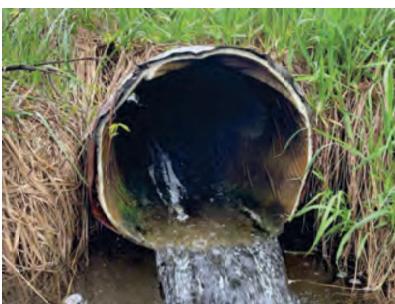
Culvert #3: Lined and perched 500 mm CSP, west of Fraser Road. Proposed to be replaced.

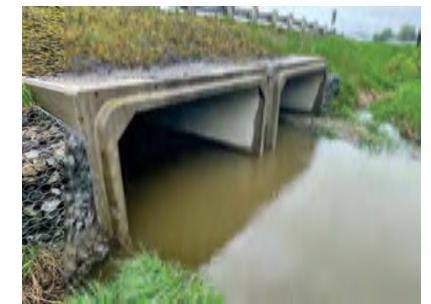
Culvert #4: Twin box culverts conveying the MacKenzie Municipal Drain. Not proposed for replacement.

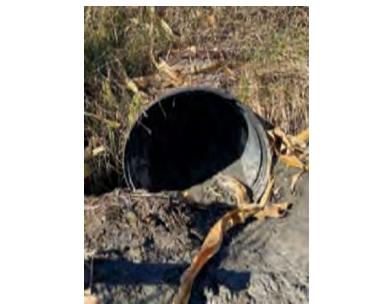
Culvert #5: 600 mm HDPE pipe. Not proposed for replacement.

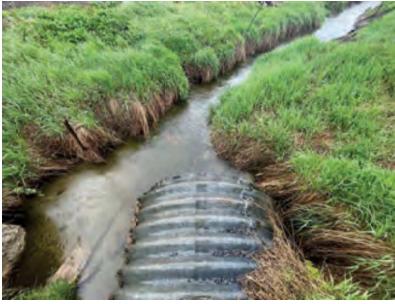
Culvert #6: Damaged, 1600 mm CSP with erosion issues conveying Cumming Drain. Proposed to be replaced.

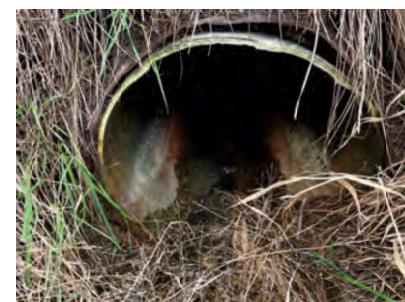
Culvert #8: Lined 600 mm CSP, 40 m west of Cumming Road. Proposed to be replaced.

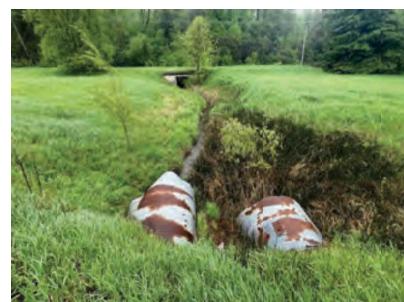
Culvert #9: Corroded, twin 1600 mm CSPs conveying the Morrow Branch of the Cumming Drain. Proposed to be replaced.

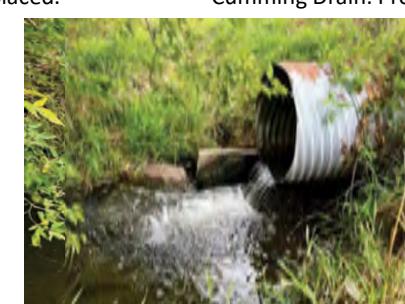
Culvert #11: Perched 900 mm CSP, east of the Maxville Manor. Not proposed for replacement. Recommend river run rock outlet.

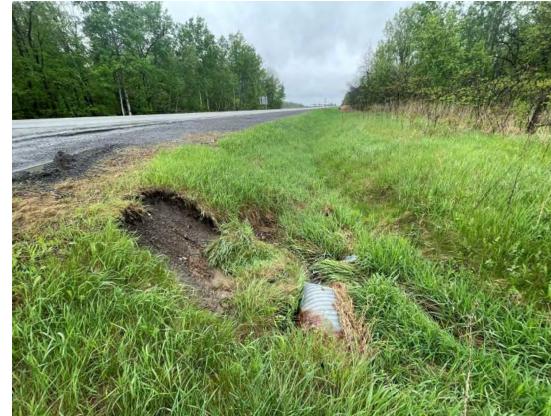
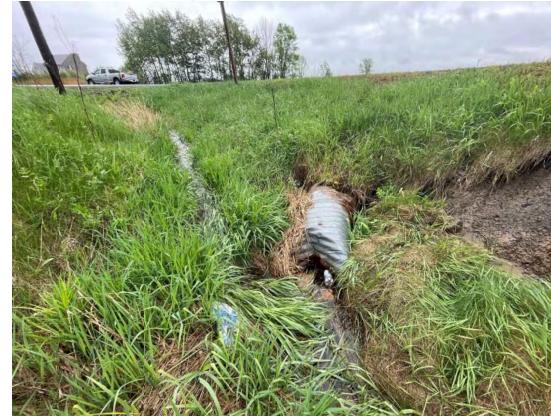
CVT 1

View of the culvert inlet looking north (above) and south (below). The 600 mm CSP is damaged at the inlet, and erosion/washout is evident along the Highway 138 embankment.

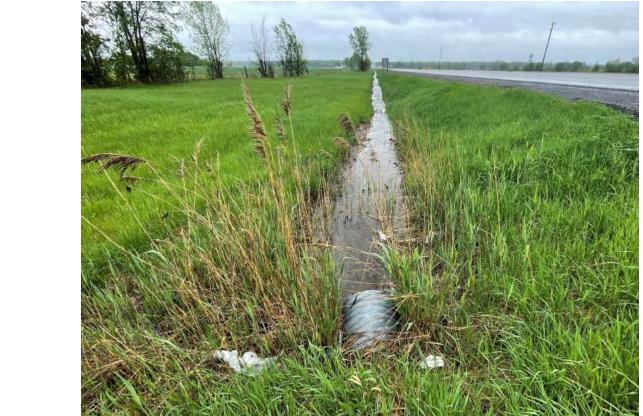
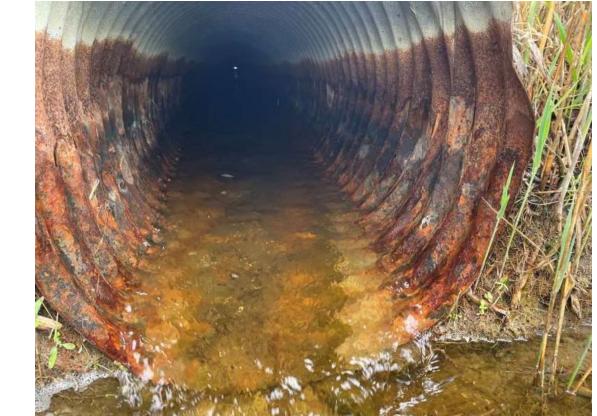
View of the culvert outlet (above) and the interior of the pipe (below). The culvert is over 50% corroded in addition to being damaged at the inlet.

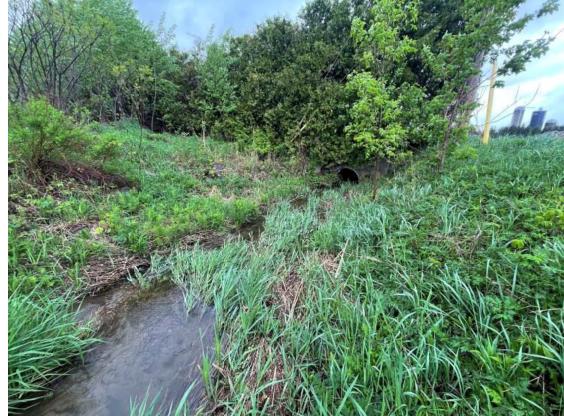
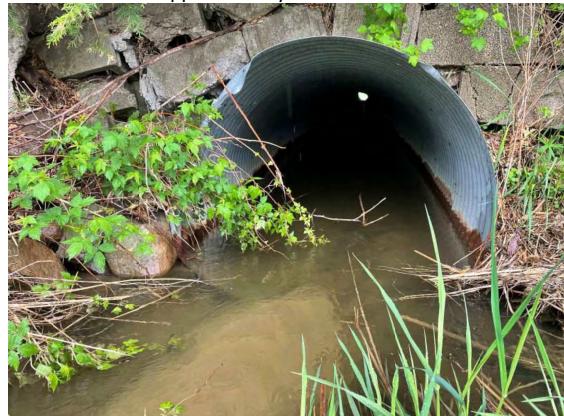
DR CVT 1 (and ditching)

View of ditch flows moving east into a 1000 mm CSP driveway culvert under 17443 CR 22 (above and below). Fish were observed. The culvert is approximately 40% corroded

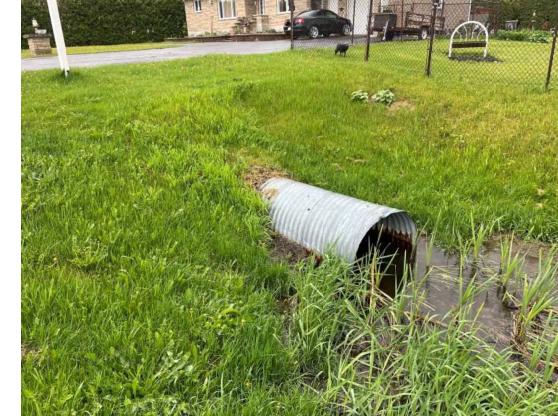
Outlet of the CSP under 17443 CR 22 (above). View of the continued ditching and associated driveway culverts further east (below).

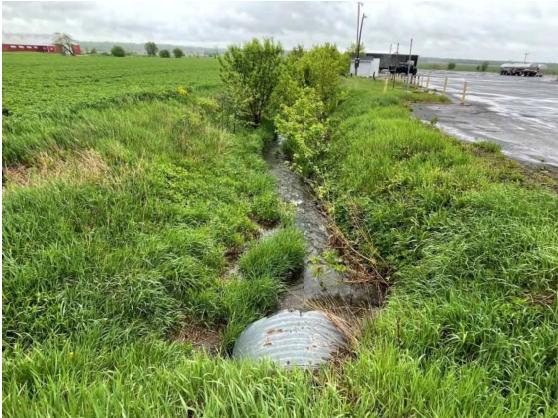
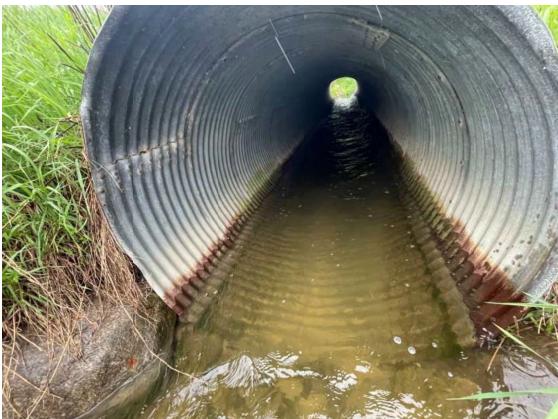
View of the culvert outlet looking south (above). View of the interior of the culvert, looking north (below). The culvert is approximately 25% corroded. Connectivity to Culvert #3 means this feature may provide fish habitat.

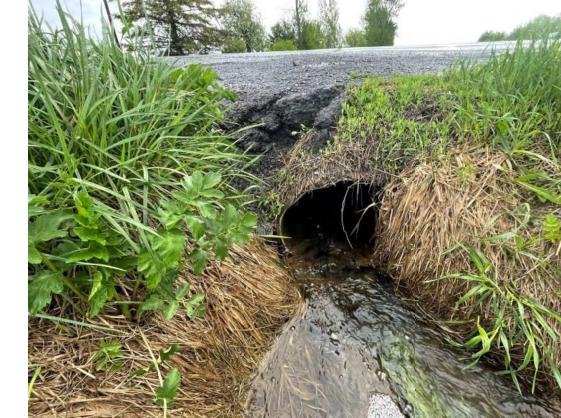
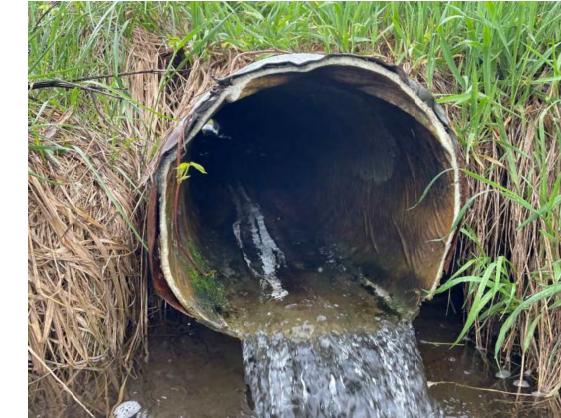
View of the culvert inlet looking south (below). Note erosion around the culvert/road shoulder. View of the perched culvert outlet and closeup of the culvert liner (below). The liner appears to be partially deteriorated.

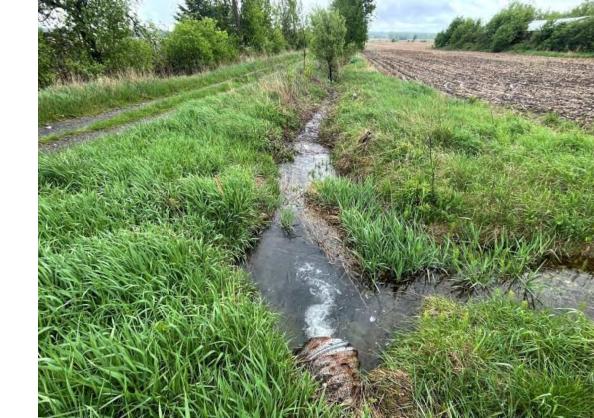
View of the culvert outlet, looking south (above). Note ditch drainage confluencing with this main channel, from the west. This culvert is immediately west of Fraser Road.

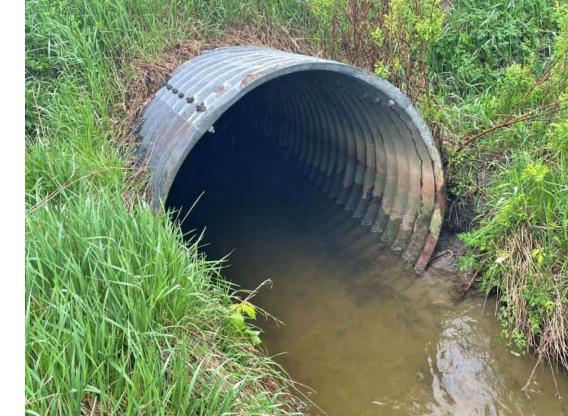
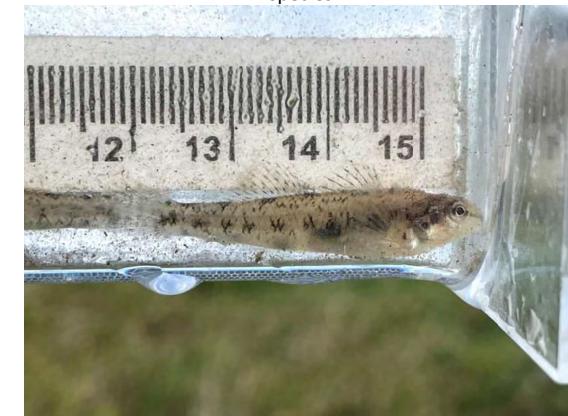
CVT 7

View of the culvert outlet, looking south (below). The CSP appears to be approximately 40% corroded. This is the Cumming Drain. Darters were captured (below) and may be either Johnny, Tessellated or a hybrid species.

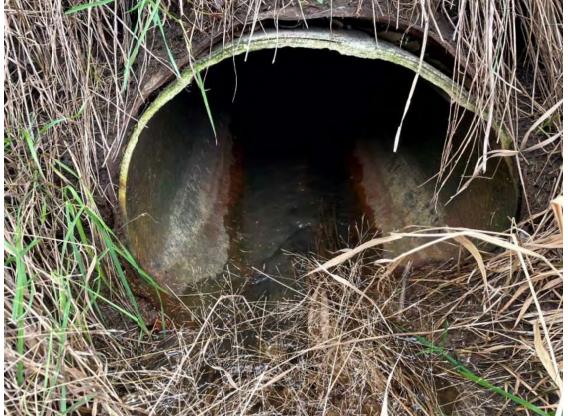
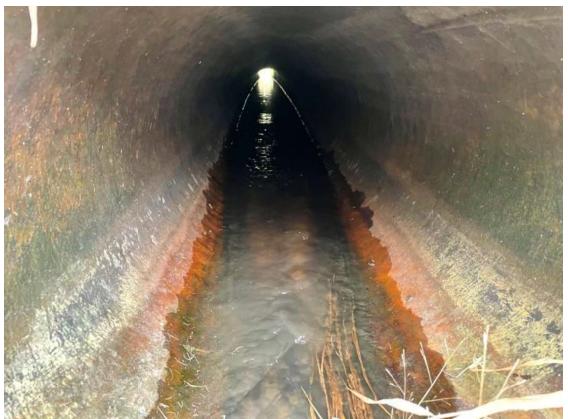
CVT 8

View of a lined, 600 mm CSP conveying drainage from a nearby agricultural drain under CR 22, eastward (above). The liner appears to be in fair condition (below).

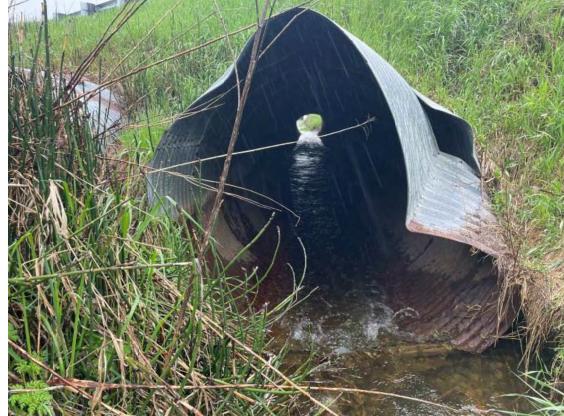
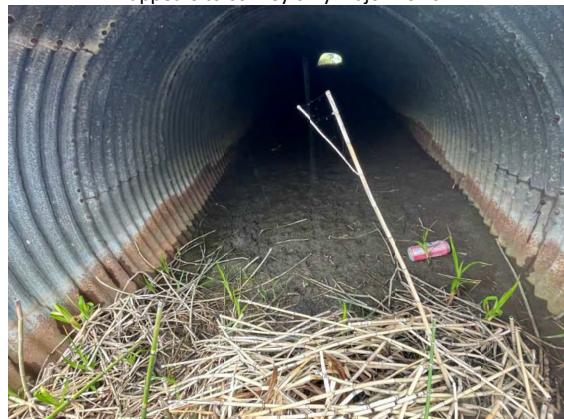
CVT 9

View of the east pipe inlet (above) and west pipe inlet (below). Note that there is significant damage to the integrity of the end of the east pipe, and both pipes are approximately 60% corroded. The west pipe is dry and appears to convey only major flows.

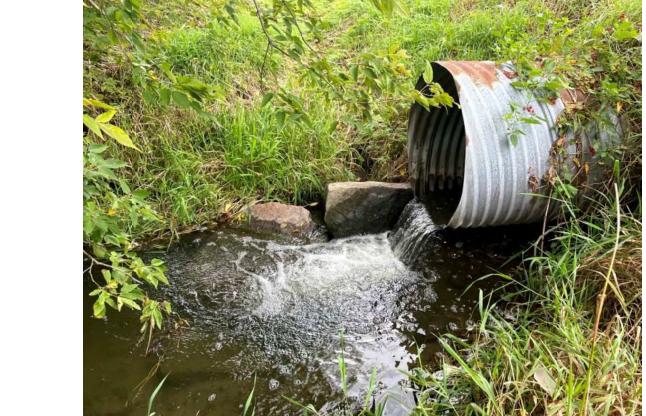
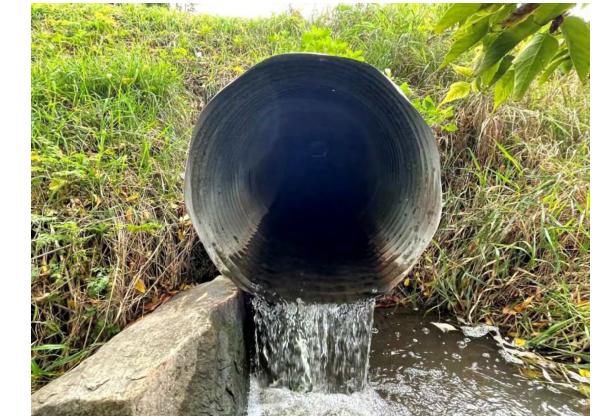
The culvert outlet is perched and approximately 25% corroded. A scour pool (0.65 m deep) has developed due to the 0.3 m perch from the culvert invert to the surface of the water.

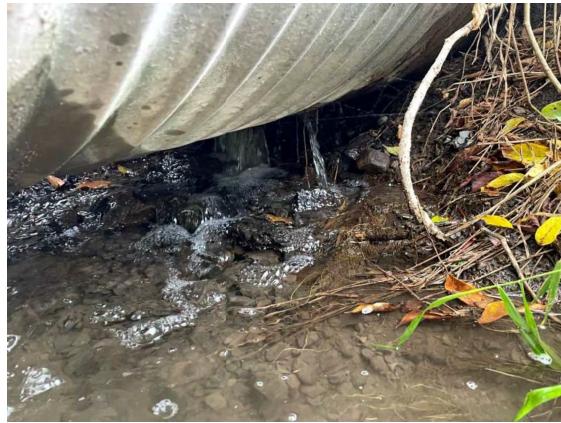
Water was observed below the pipe (above), although it is unclear if the barrel has a leak or if water is running along the exterior of the culvert.
