Notice of Study Commencement United Counties of Stormont, Dundas and Glengarry County Road 22 Reconstruction and Drainage Improvements

A survey was conducted on May 17, 2022, to document existing cross culverts which may require replacement within the limits of the County Road 22 (CR 22) Project Area. Additionally, cross culverts and subsamples of driveway culverts and drainage ditches (mostly components of municipal drains) were cursorily assessed to determine if any have the potential to provide fish habitat. An additional survey was completed on September 28, 2022, to both identify additional culverts in the expanded Project Area (eastward) and to complete fish community surveys at select locations where potential fish habitat was identified. This was a non-exhaustive assessment of fisheries potential in the Project Area from which a submission package to environmental regulatory agencies could be developed.

ATTACHMENT 2 – Photographic Diary

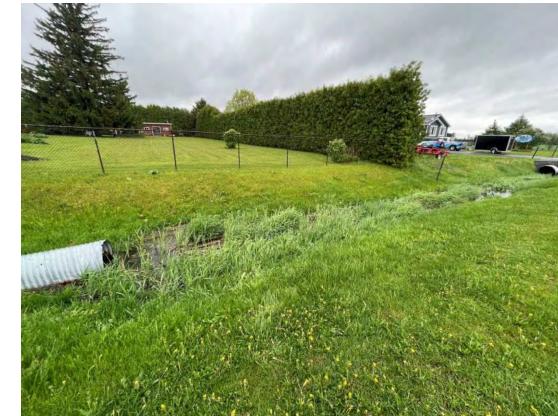
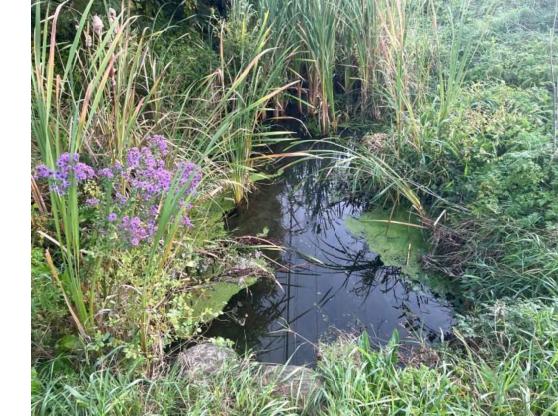
CVT 2

The outlet of the CSP under 17443 CR 22 contained significantly more vegetation and cattail growth during the fall visit (above). Blacknose Dace (some spawning colouration) and Fathead Minnow were captured during a presence/absence survey (below).

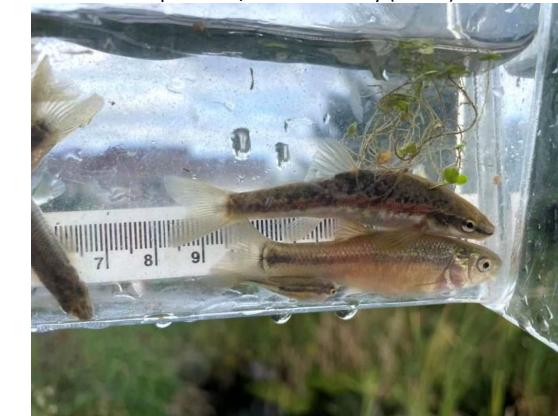
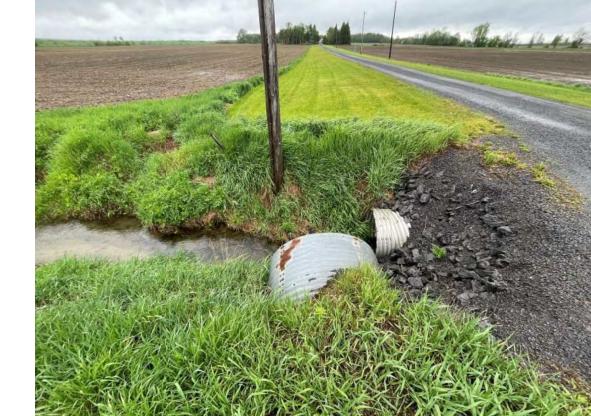
View of the 1500 mm CSP immediately west of 17515 CR 22, looking north (above). View of the culvert inlet looking south (below). Note the driveway culvert immediately to the east.

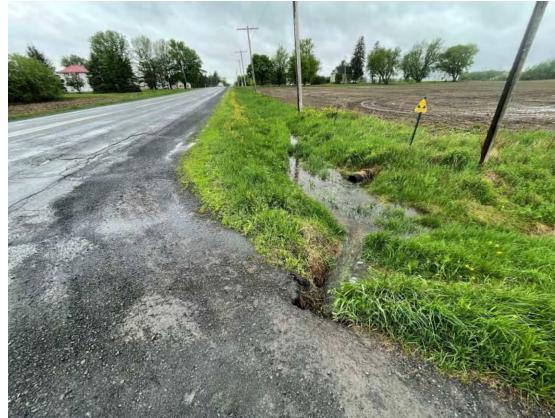
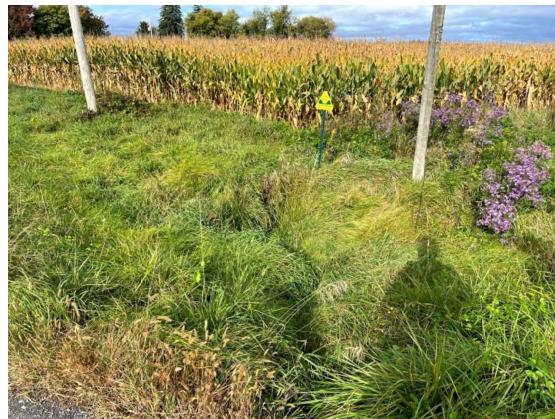
CVT 3

View of the inlet of the 500 mm, lined CSP looking northwest to capture drainage coming from the west (above). The same inlet was nearly dry in September (below).

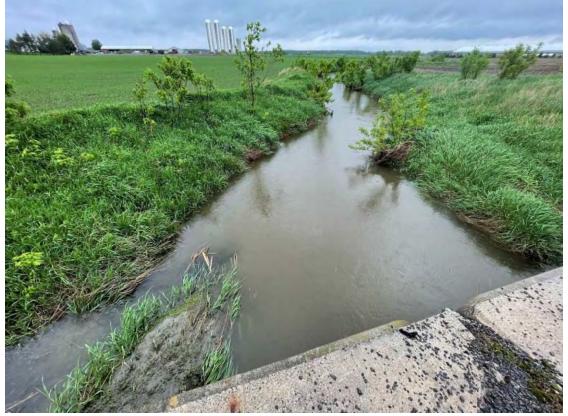
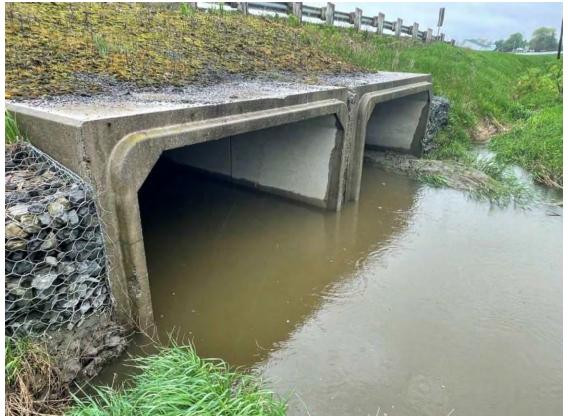
CVT 4

View of the box culverts outletting to the north (above). View of the culvert outlets, looking southwest (below). This feature is the McKenzie Municipal Drain.

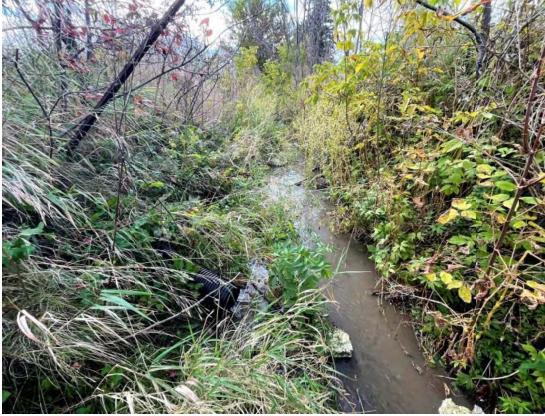
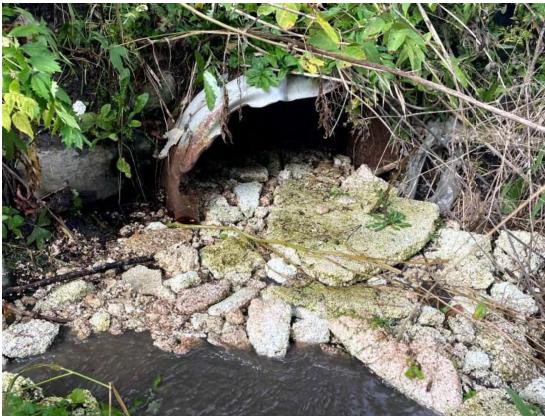
DR CVT 2

View of drainage flowing north (above) to a 700 mm CSP (below) under a field access/driveway at 17670 CR 22. Water was backed up in May and September.

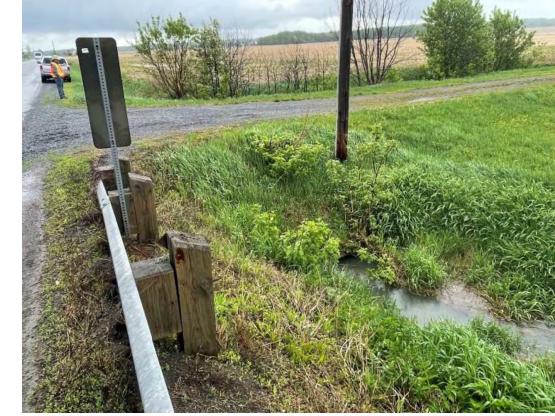
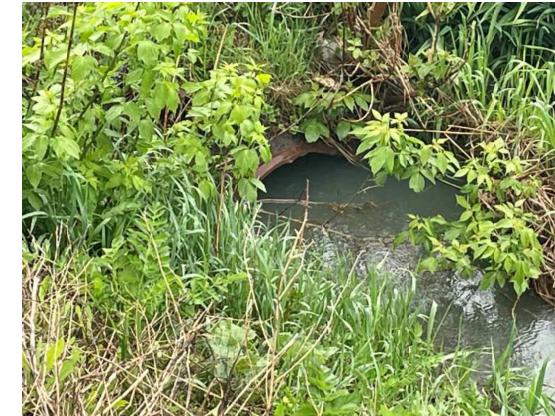
CVT 5

View of the culvert crossing (outlet) under 17670 CR 22 looking southeast. Closeup of the culvert outlet (below) which is nearing maximum capacity. Outletting water is discoloured and enters McKenzie Municipal Drain 20 m to the west.

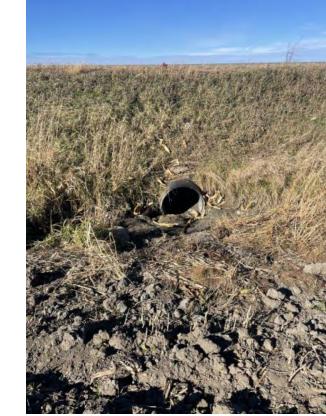
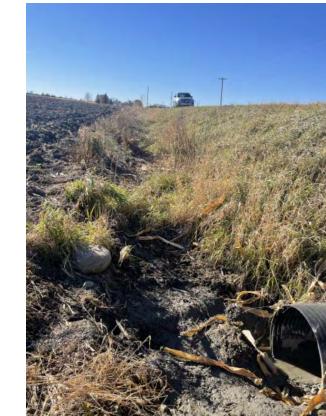
View of the 600 mm PVC cross culvert approximately 390 m east of the McKenzie Municipal Drain crossing under CR 22. This feature does not support fish habitat (directly or indirectly).

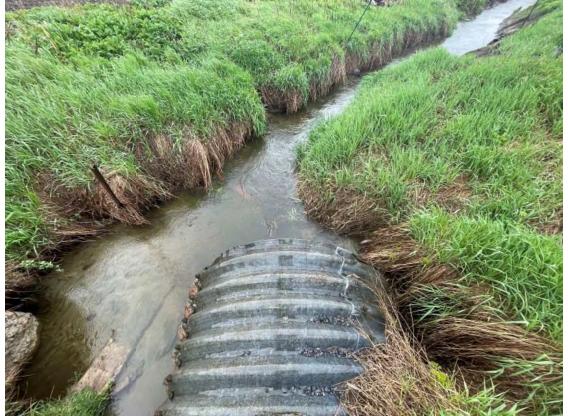
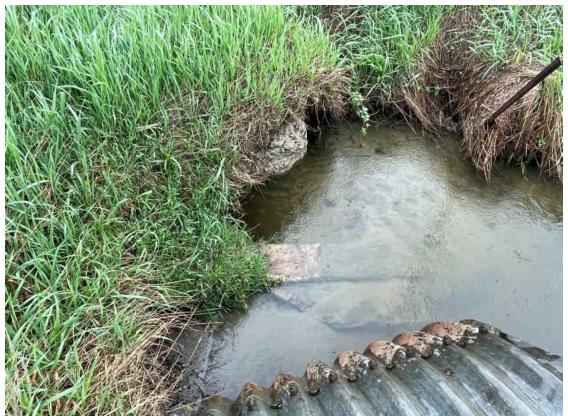
CVT 6

View of the 1600 mm CSP culvert inlet, looking south (above). Note bank erosion on either side of the inlet. Photo of remnant concrete (below), east of the culvert inlet.

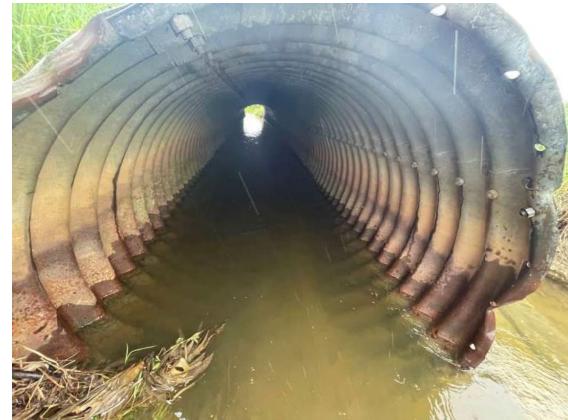
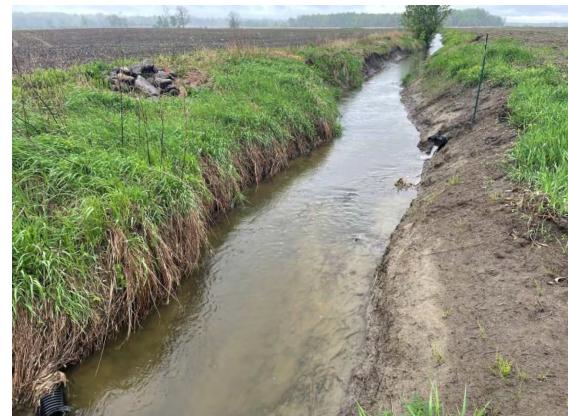
View of the interior of the CSP at the culvert inlet (above). View of eroding banks further to the south (below). It appears that this channel has recently had a cleanout.

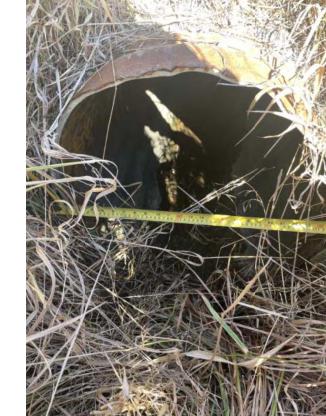
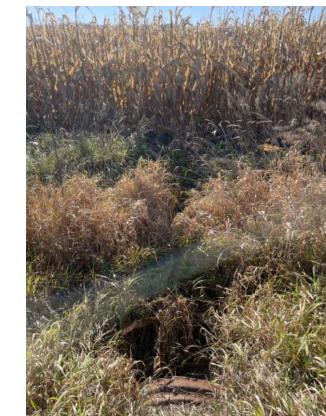
View of the lined, 600 mm CSP crossing under CR 22. This culvert conveys runoff from nearby agricultural fields and does not provide fish habitat.

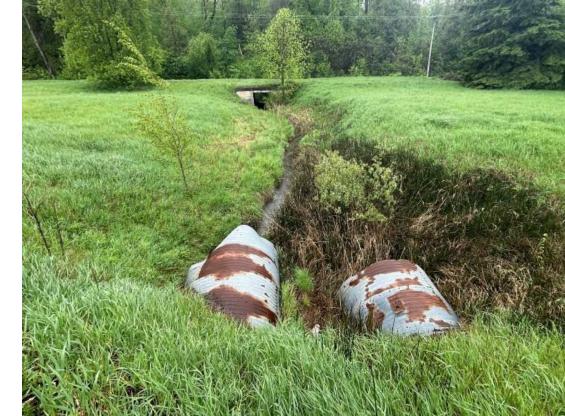
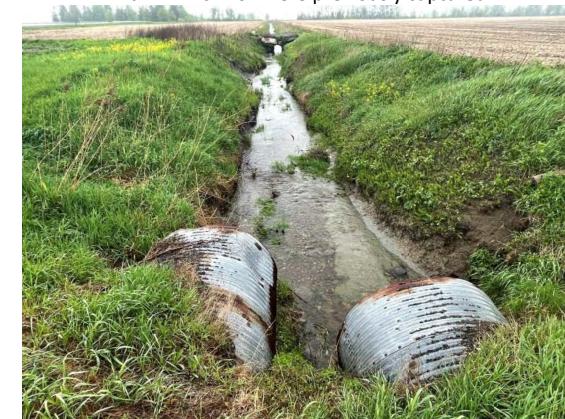
CVT 10

View of the twin 1500 mm culvert inlets (above), and the old road alignment further south. View of the CSPs outletting to the north (below). No fish were captured; however, this is a branch of the Cumming Drain within which fish were previously captured.

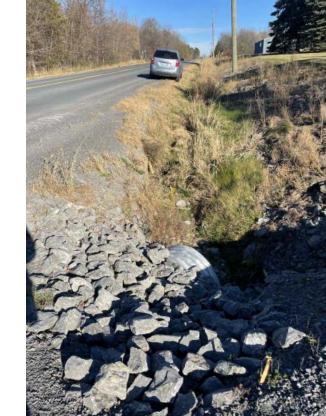
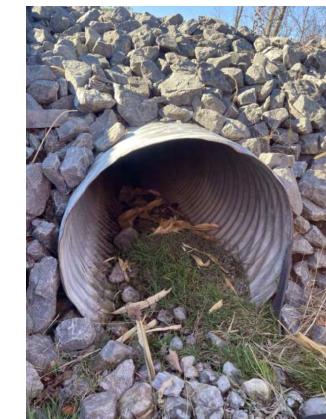
View of the 800 mm CSP crossing under CR 22 looking east on the south side of the road (above) and looking at the inlet, looking north (below).

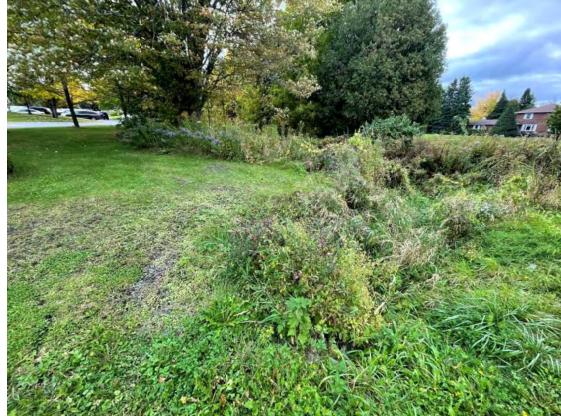
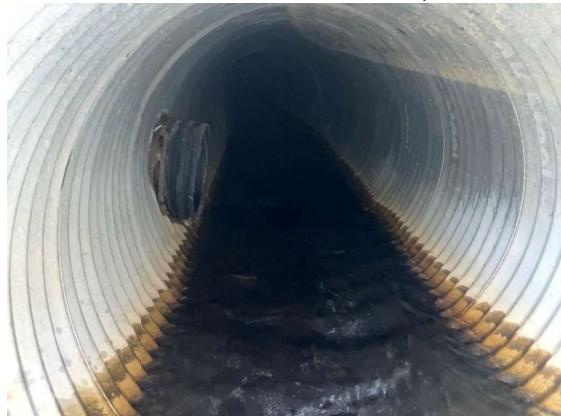
DR CVT 3

Drainage from agricultural fields to the south flow north through a swale (above) and into an 800 mm CSP (below). Flow is conveyed east under the entrance to the Maxville Manor to a catchbasin. One catchbasin connection from the north can be seen, below.

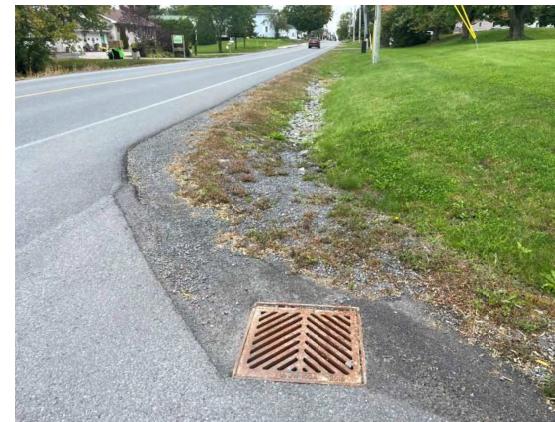
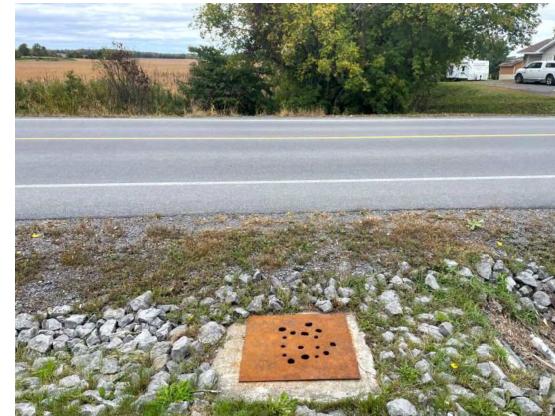
Flow enters the above catchbasin at the east limit of the Manor driveway before it continues east to a confluence point of east and west drainage (below) which is ultimately directed to the north.

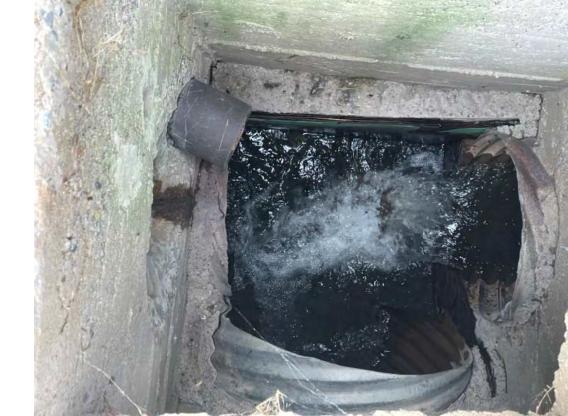
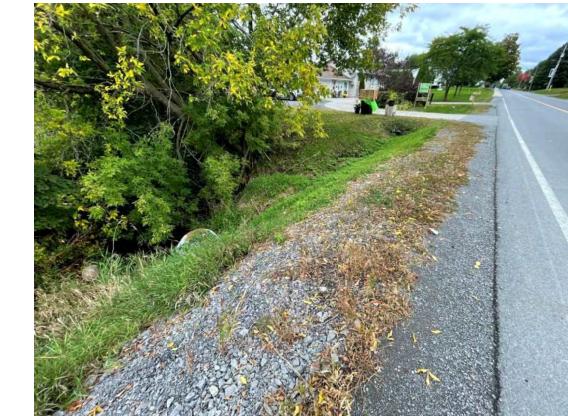
CVT 11

Top-down view of the confluence point (above). The 800 mm CSP enters from the west (right pipe) and a storm inlet enters from the east (left pipe). Flow then moves north through a 900 mm CSP (above and below).

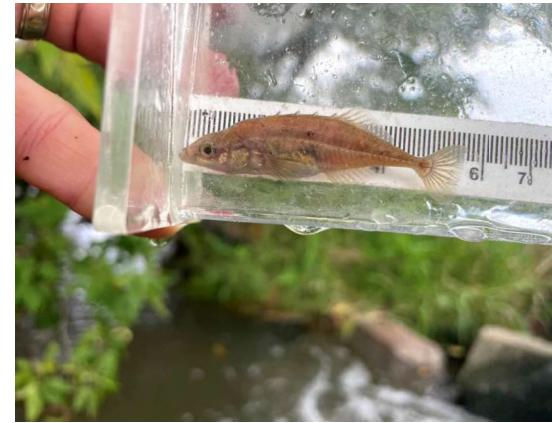
One Brook Stickleback (above) was captured during a presence/absence survey.
